Inside Fire

Whitemore Fire Consultants, Inc.

January 2013

Investigating Fire Losses Involving CSST by Duane A. Wolf, MSPE

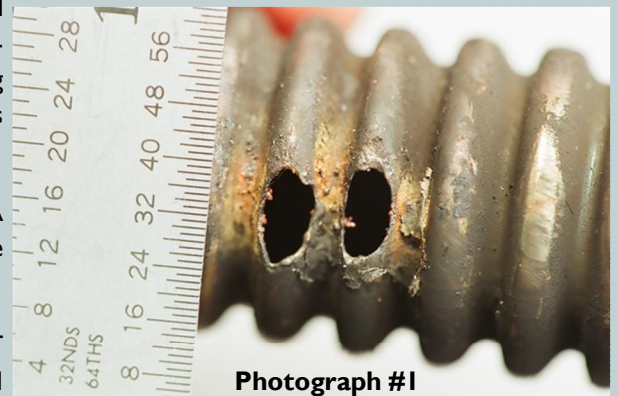
As indicated previously, CSST is constructed of thin-walled corrugated stainless steel tubing. A typical wall thickness of $\frac{3}{4}$ " CSST is 0.010". For comparison purposes, $\frac{3}{4}$ " black iron pipe (standard) has a wall thickness of 0.113" and $\frac{1}{2}$ " K-copper has a wall thickness of 0.049". It is the thin-walled construction of CSST which makes it susceptible to failure as a result of electrical activity. For comparison purposes, the author has investigated several lightning induced failures of copper tubing and no lightning induced failures of black iron piping. Based upon the field experience of the author, there is a very strong direct correlation between the wall thickness of the particular style of gas tubing and the magnitude of the resistance to lightning induced failures.

Photograph #1 is an example of a lightning induced failure in CSST. A ruler is also included in the photograph to provide some representative dimensions of the holes which were observed in the CSST.

The electrical activity shown in Photograph #1 occurred between the CSST and a section of abandoned black iron gas pipe such that the same electrical arc which caused the damage shown in Photograph #1 also caused the damage to the black iron pipe shown in Photograph #2. It can be seen that the damage suffered by the black iron pipe consisted of some surface pitting, but the wall thickness was sufficient to prevent full penetration of the black iron pipe and a compromise of the integrity of the black iron pipe. These two photographs provide further documentation that the susceptibility of CSST to lightning induced failures is primarily due to its wall thickness.

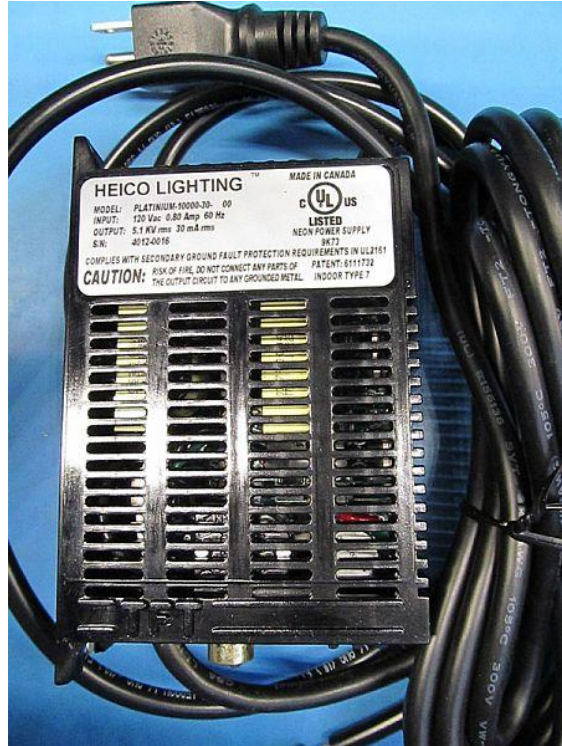
Model PLATINUM-10000-30

The U.S. Consumer Product Safety Commission in cooperation with HEICO Lighting, a Division of EMD Technologies of Montreal, Quebec, Canada, has issued a voluntary recall of the Platinum Neon Power Supply Transformers. The transformers were manufactured in Canada and have been determined to not meet UL standard for this product. Approximately 3,900 units were sold directly by HEICO distributors nationwide from December 2011 through May 2012 for between \$60 and \$150. The ten distributors are Denco Sales, Graphic Solution, Hart Supply, Interstate Electric, Montroy Supply Company, N. Glantz & Son, Pioneer Supply, Reece Supply Company, Sun Supply, and Tubelite Company.

This recall involves neon power supply transformers designed to power commercial signs. They are in black metal boxes about 4.5 inches long by 3.5 inches wide with rows of vents on all sides. "HEICO LIGHTING™" and the model information are printed on a plate on the transformer. The recalled models include PLATINUM-9000-30, PLATINUM-10000-30, PLATINUM-12000-30, TFT-04PL-6000-30, and TFT-06PL-9000-30. No incidents have been reported.

Consumers should stop using these recalled power supply transformers and unplug them immediately until a free replacement transformer has been professionally installed. Contact HEICO lighting to schedule the free installation of a replacement transformer.

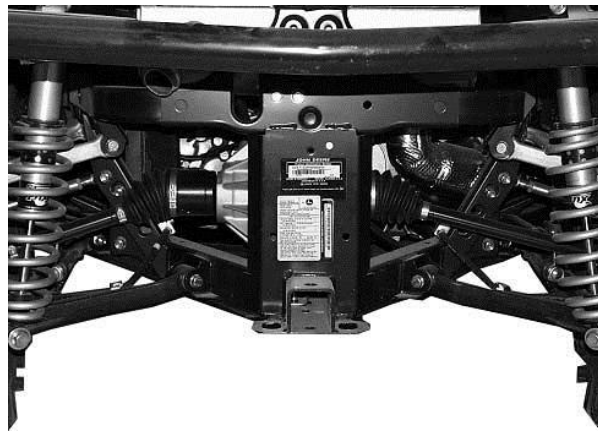
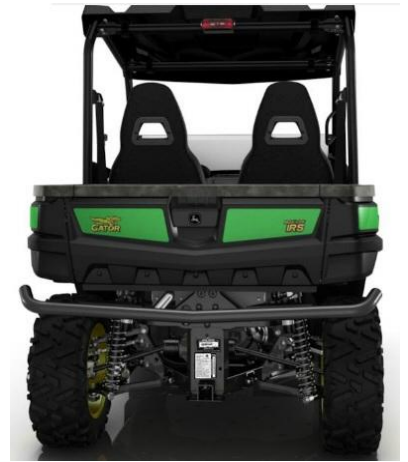
Deere & Company of Moline, Illinois in cooperation with the Consumer Product Safety Commission has recalled approximately 4,650 Utility vehicles. The fuel line can separate, posing a fire hazard to consumers.

John Deere has received three reports of a separated fuel lines, however no injuries have been reported.

This recall involves the John Deere Gator™ RSX850i Base, Sport and Trail model recreational utility vehicle manufactured between May 2012 and October 2012. They have side-by-side seating for two people and were available in Realtree® Hardwoods™ HD Camo, olive and black, or traditional green and yellow. RSX850i is located on the hood. The serial number is on the rear frame above the receiver hitch. Only utility vehicles with the following serial numbers are included in this recall:

Consumers should stop using the recalled utility vehicle and contact a John Deere dealer to schedule a free inspection and free repair. John Deere is contacting all registered owners of the recalled vehicles directly. For more information, visit the firm's website at: www.johndeere.com and click on Services & Support.

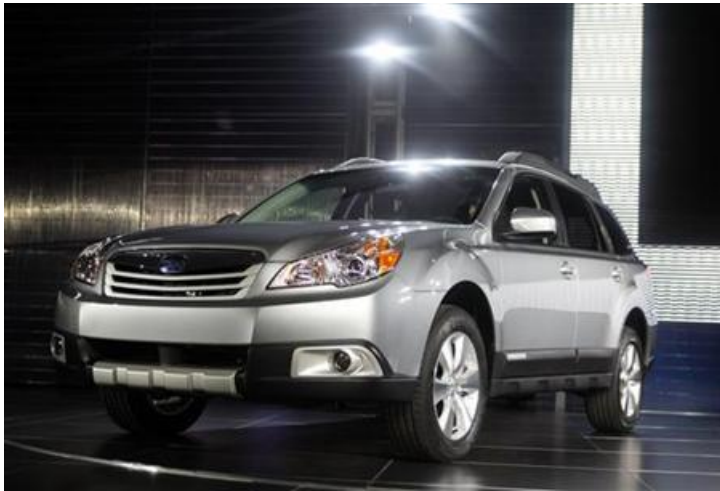
Subaru is recalling as many as 634,000 vehicles in the United States for potential lighting problems that could lead to smoke or fire, according to U.S. safety regulators.

The 633,842 vehicles potentially affected by the recall may be equipped with accessory puddle lights that when lit brighten the areas under the doors. According to Subaru, the recall involves only 53,999 cars equipped with the lights, but the wider number of owners must be alerted because the company does not know which cars have them.

There have been no reports of accidents or injuries related to this recall, but there was one report of smoke. A short circuit can develop when the light or connector are exposed to an electrolytic moisture source such a road spray that has road salt in it. This can cause heat that could melt plastic, resulting in smoke or fire.
