## The Scary Side of Electrical Fires & Accidents, by Beth Anderson, P.E.

### Handy Homeowner Devises Own Demise

### Low Voltage Circuit Ignites Fall Leaf Debris

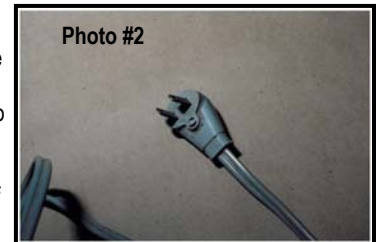
Photo #2

The first line of defense in this appliance is the grounding conductor that is attached to the housing. The grounding conductor is there to provide a current path to ground in case the housing becomes energized. Unfortunately, in this case that grounding conductor was severed at the plug. (See photograph #2). With the ground blade missing from the plug, there is no path except through the homeowner's body, for current to flow to ground.

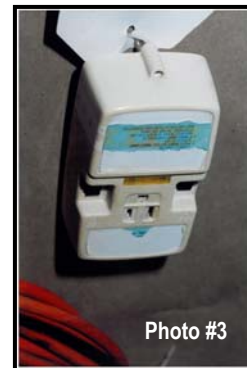
Photo #3

The second line of defense is the Ground Fault

Circuit Interrupter. Even without a continuous ground path, the GFCI should have detected the fault current. A GFCI is a current comparator. Current going to the appliance is measured against current returning from the appliance. If a differential is detected, the GFCI interrupts power to the appliance.

The threshold of detection is 5 milliamps in most household GFCIs. This is well below the amount of current it takes to put the heart into fibrillation. Unfortunately, this GFCI had also been repaired. (See photographs #3 and #4.) The GFCI is clearly old and harshly used. Notice the screws on the rear of the GFCI, the two on top are a different color and it appears that cuts have been made in the housing and screws to allow removal. Clearly the GFCI didn't operate properly as the witness also received a shock and yet the pump continued to operate.

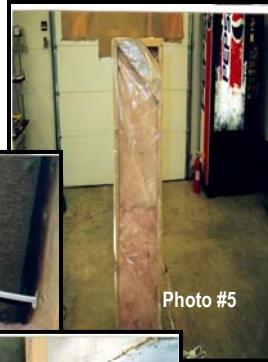
Inspection of the conductors revealed a scrape mark on the hot conductor. (See photograph #4.) The

scrape was clearly caused by mechanical damage to the conductor. A Scanning Electron Microscope (SEM) inspection of the conductor found traces of iron inside the scraped surface of the wire. All of the staples used in construction were made of iron. Testing of a similarly constructed wall indicated that it was possible for high resistance heating to ignite the fiberboard without causing the copper conductors to melt. Photograph #5 shows the exemplar wall space and circuit. Photograph #6 shows the introduction of resistors into the circuit that produce heat when energized. This simulates

resis- current would intro- a sta- ing in with the wires. Photograph #7 shows the fire that ignited during the test.

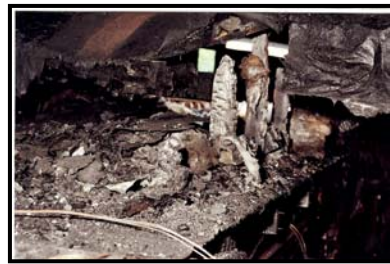
The area of fire origin was clearly defined above the bar. (See photograph #3.) Several electrical circuits ran through this area, yet none of them serviced the newly installed duct fans. One of the ways electricity can cause a fire is through an arcing event. Arcing occurs when electricity passes through air and creates heat and light, similar to a lightning strike. Temperatures in an arcing event can reach 6000°F and leave evidence of

Evidence of an arcing event was found in the area of origin.

One conductor in the circuit had a small bead of copper along the side of the wire. The wire next to it had a matching nick in the wire. However, neither wire was severed during the arcing event.

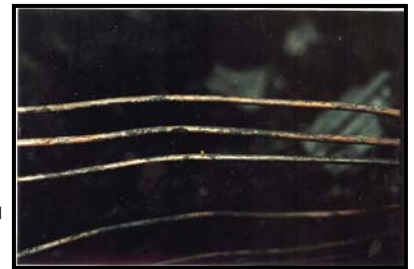
What starts out as a high resistance, low current, arc track can end up being a short on a conductor drawing enough current to trip the circuit breaker. Sometimes the last thing that happens in an electrical failure is the arcing through air that produces temperatures high enough to melt metal. (See photograph #5.)

In this case, the arcing started out as an arc-tracking event building up heat in a localized area. The heat build-up was enhanced by the thermal insulation in the attic. Even though the circuit breaker eventually tripped, it did not prevent this fire.

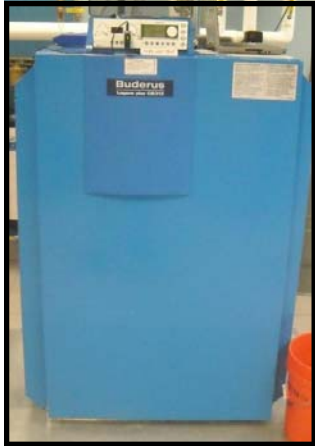
The recall involves the Buderus GB312 gas-fired, floor standing condensing boilers. Model numbers included in this recall are: 312/90, 312/120, 312/160, 312/200, 312/240 and 312/280. "BUDERUS GB312" is printed on the front of the boiler. The boilers are blue, approximately 60" high and between 39-55" wide.

The boilers were sold at plumbing and heating wholesale distributors to plumbing and heating contractors nationwide from April 2008 through February 2009 for between \$12,000 and \$24,000 installed. Bosch has directly contacted consumers who purchased the recalled boilers, inspected and, if necessary, repaired the boilers.

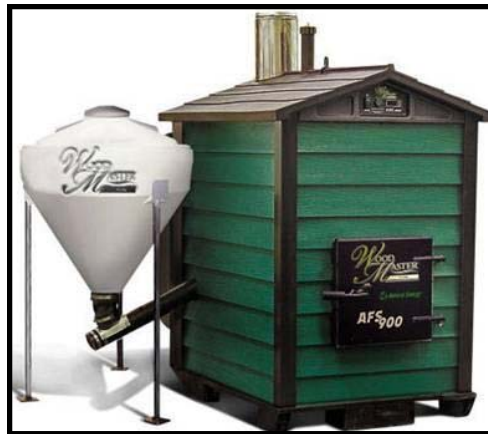
The temperature gauge can fail and cause fire in the fuel storage hopper, posing a fire and burn hazard to consumers. Twelve incidents of fire in the fuel storage hopper have been reported, three of which reported blisters and minor burns to the hands.

This recall involves the WoodMaster AFS 900 outdoor furnace. The furnaces were sold in green, black, brown, camo, grey, red and taupe. The WoodMaster logo AND AFS900 are on the front and were sold at authorized plumbing and heating stores nationwide and direct sales between July 2006 and February 2009 for about \$6,000.

Consumers should stop using the recalled furnaces immediately and contact Northwest Manufacturing to schedule a free repair. All known consumers have been notified. For additional information, contact Northwest Manufacturing at (800) 932-3629 between 8 a.m. and 5 p.m. CT, Monday through Friday, or visit the firm's Web site at [www.AFS900recall.com](http://www.AFS900recall.com).

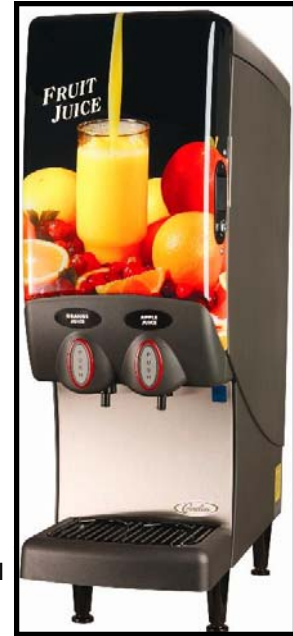
Fraying of wiring within the wiring harness can cause the juice dispenser's transformer to overheat, posing a fire hazard. IMI Cornelius has received one report of a transformer smoldering and smoking. No injuries or property damage have been reported.

The recalled commercial juice dispensers have two or four dispensing valves with an illuminated or opaque rounded front cover. For a complete list of the serial numbers involved in this recall, please visit [www.cornelius.com](http://www.cornelius.com). The serial number can be found on the inside of the front door of the dispenser. The juice dispensers were sold to commercial customers for installation in hospitality and other food service establishments nationwide from February 2001 through August 2006 for about \$2,000 (2-flavor unit) or about \$3,200 (4-flavor unit).

Customers should unplug the unit, open the door, and inspect the wire harness in the bottom left corner of the cabinet. If the colored wiring is cut or cracked (see photos below), customers should immediately stop using the unit and contact IMI Cornelius. IMI Cornelius is contacting all customers directly to provide a free repair kit. For additional information, call IMI Cornelius at (800) 344-3801 between 7:30 a.m. and 5 p.m. CT Monday through Friday, or visit the firm's Web site at [www.cornelius.com](http://www.cornelius.com).
